Coefficients of friction for wheel studs and threaded connections with spigot mountings.

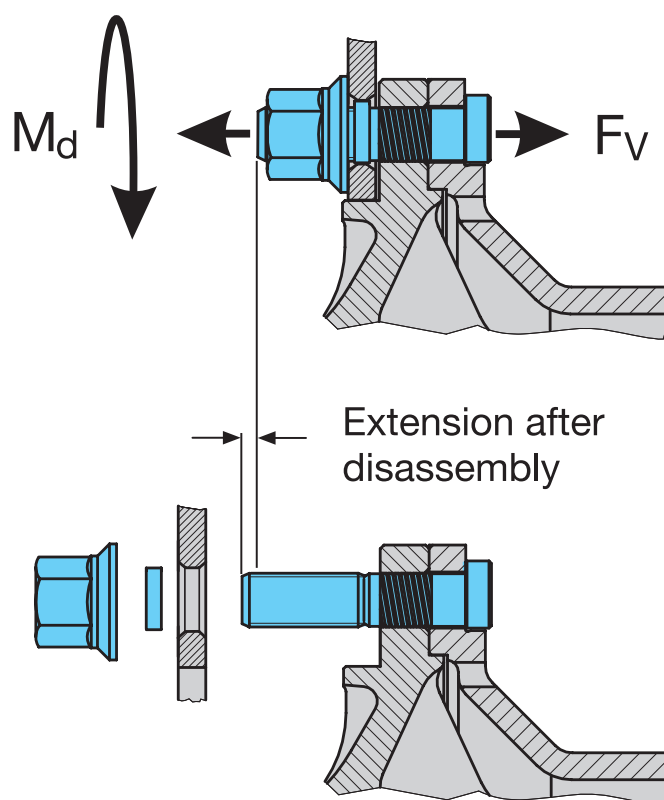
- ⦿ Lubricating the threads will result in a **reduced coefficient of friction** and will produce **higher preload forces** in the threaded connection. If this force is greater than the maximum allowable force, it **will stretch the bolt to the point of plastic deformation** and then distort the thread. BPW's tests have shown that lubricating the wheel stud threads can result in over tightening of the threaded connections by 20 to 30% more than with clean dry threads, and sometimes by as much as 60%.
- ⦿ The tightening torque and **resultant coefficient of friction, when tightening threaded connections that are not clean**, eg. a rusted or painted surface, will result in a **lower preload force**. In these cases, **there is a risk that the residual clamping force may no longer be sufficient and, in extreme cases, the threaded connection may become loose.**

In conclusion, it should be noted that when refitting wheel nuts to wheels studs, the threads are NOT to be lubricated and are to be dry and clean so that the required coefficient of friction can be achieved, **otherwise the safety risk and potential for damage is high!**
